**Flood Control Project Maintenance
Levee Inspections**

Spring 2012 Levee Inspection Results

Sacramento Maintenance Yard Maintenance Area 0009

Waterway			Bank	Unit Miles
Unit No. 01 Sacramento River			Left	19.61
	Spring (March - May)	Summer (June - August)	(September - November) Fall	Winter (December - February)
Unit Maintenance Rating (Fall Only)				
Date of Inspection	5/1/2012 - 5/2/2012			
DWR Inspector	John Williamson			
Accompanied By	Dave Williams Sacramento Maint.			
	Iris Flores Sacramento Maint.

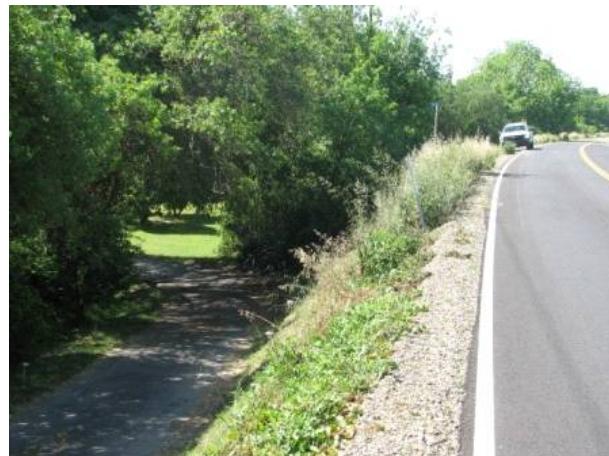
johngw_s_20120504_785.jpg

Levee Mile Report Line	187
Start Levee Mile	10.89
End Levee Mile	10.89
Location	Land Side
Category	Earthen Levee
Item	Vegetation

A view of the drive and landscape. Photo taken spring 2012.

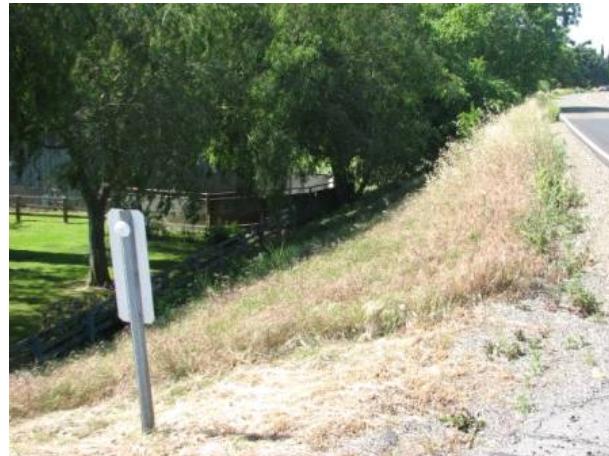
johngw_s_20120504_786.jpg

Levee Mile Report Line	188
Start Levee Mile	10.94
End Levee Mile	10.94
Location	Land Side
Category	Earthen Levee
Item	Vegetation

A view of the horse corral and some landscape. Photo taken spring 2012.

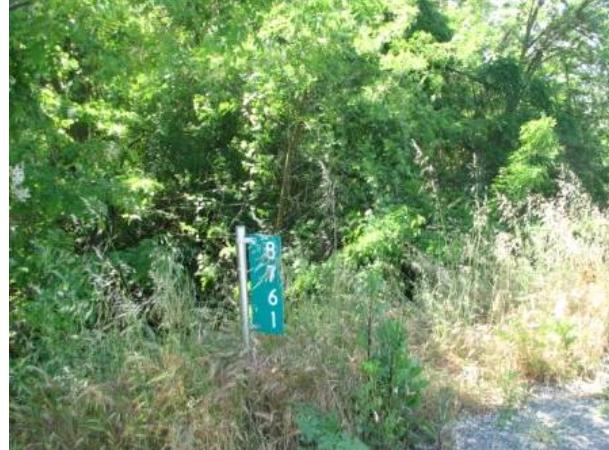
Levee Mile Report Line	189
Start Levee Mile	11.08
End Levee Mile	11.08
Location	Land Side
Category	Earthen Levee
Item	Vegetation
The dense landscape on the levee slope. Photo taken spring 2012.	
johngw_s_20120504_787.jpg

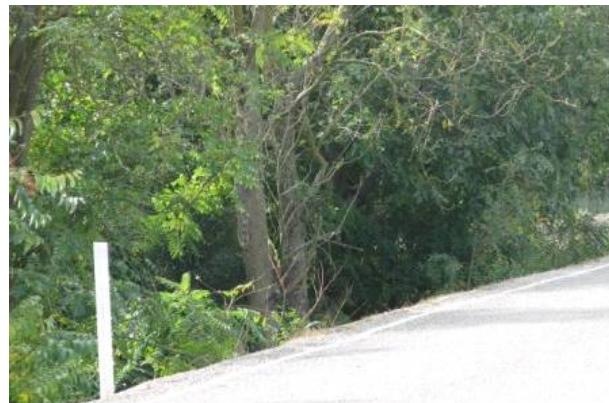
Levee Mile Report Line	190
Start Levee Mile	11.14
End Levee Mile	11.14
Location	Land Side
Category	Earthen Levee
Item	Vegetation
The landscape shrubs and trees are on the levee slope and block visibility. Fall 2011	
johngw_s_20120313_113.jpg

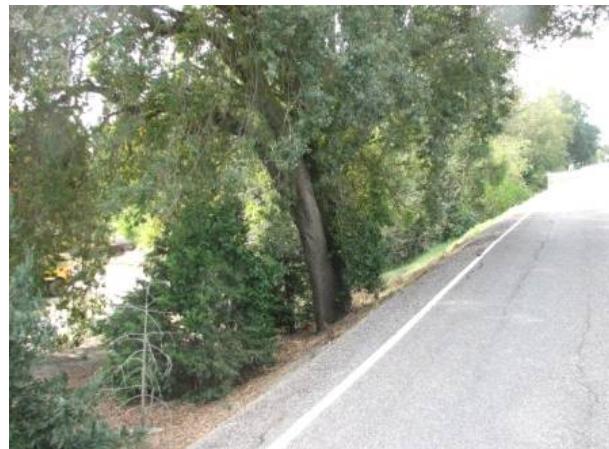
Levee Mile Report Line	191
Start Levee Mile	11.18
End Levee Mile	11.18
Location	Land Side
Category	Earthen Levee
Item	Vegetation
There is landscaping planted on the levee slope. Fall 2011	
johngw_s_20120313_112.jpg

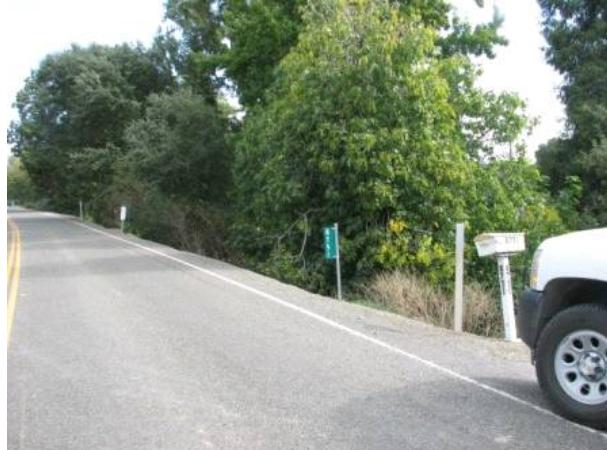
Levee Mile Report Line	192
Start Levee Mile	11.21
End Levee Mile	11.21
Location	Land Side
Category	Earthen Levee
Item	Vegetation
Landscape trees are blocking visibility. Fall 2011	
<i>johngw_s_20120313_111.jpg</i>

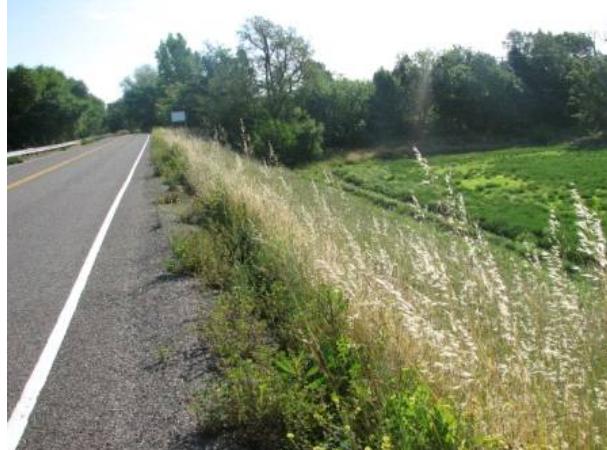
Levee Mile Report Line	194
Start Levee Mile	11.36
End Levee Mile	19.58
Location	Land Side
Category	Earthen Levee
Item	Vegetation
The grasses are taller than 12". Photo taken spring 2012.	
<i>johngw_s_20120504_788.jpg</i>

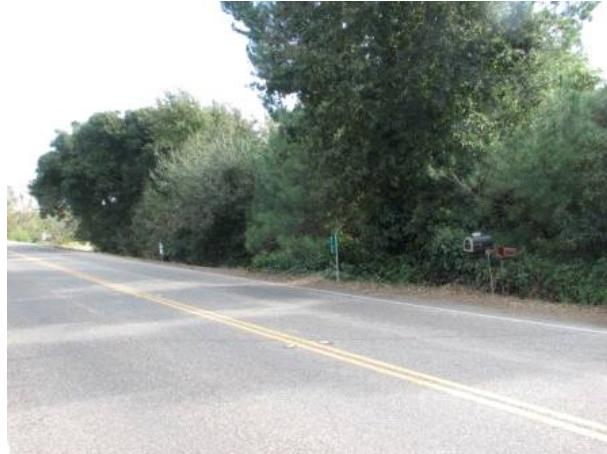
Levee Mile Report Line	195
Start Levee Mile	11.46
End Levee Mile	11.46
Location	Land Side
Category	Earthen Levee
Item	Vegetation
The landscaping is planted on the levee slope and shoulder. Fall 2011	
<i>johngw_s_20120313_110.jpg</i>

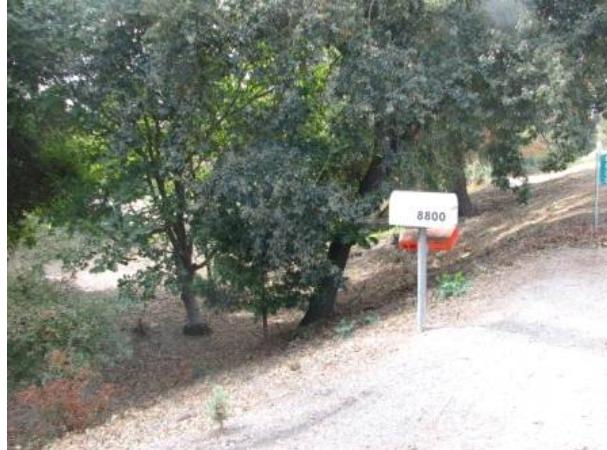
Levee Mile Report Line	196
Start Levee Mile	11.50
End Levee Mile	11.50
Location	Land Side
Category	Earthen Levee
Item	Vegetation
The landscape is planted on the levee slope with the trees and shrubs trimmed up. Fall 2011	
johngw_s_20120313_109.jpg

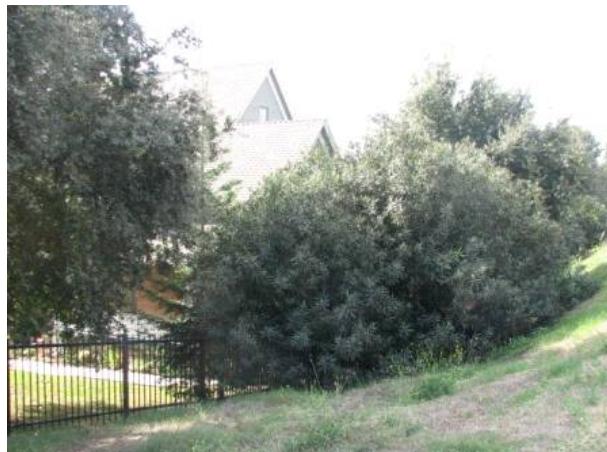
Levee Mile Report Line	197
Start Levee Mile	11.67
End Levee Mile	11.67
Location	Land Side
Category	Earthen Levee
Item	Encroachments
The building and landscape shrubs are at the toe of the levee. Fall 2011	
johngw_s_20120313_108.jpg

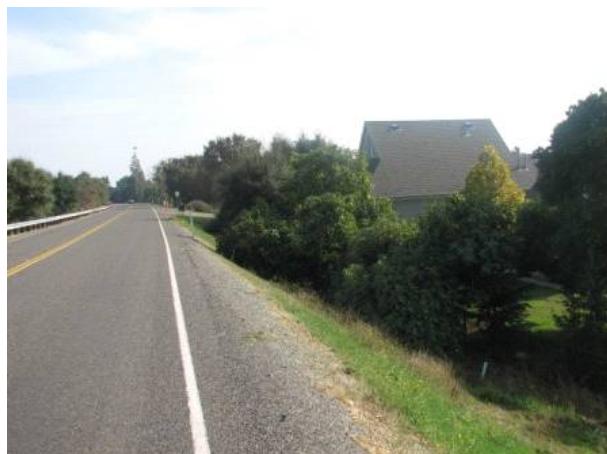
Levee Mile Report Line	198
Start Levee Mile	11.68
End Levee Mile	11.68
Location	Land Side
Category	Earthen Levee
Item	Vegetation
Fence and shrubs are along the toe of the levee.	
johngw_s_20120313_107.jpg

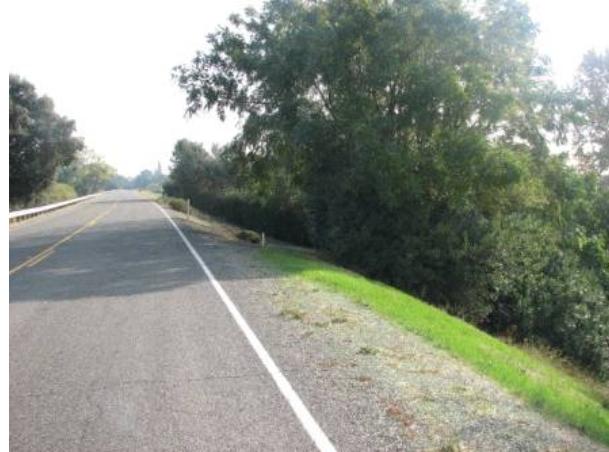
Levee Mile Report Line	200
Start Levee Mile	12.14
End Levee Mile	12.14
Location	Land Side
Category	Earthen Levee
Item	Vegetation
Oleanders are planted on the levee toe and slope to screen the house.	johngw_s_20120313_106.jpg

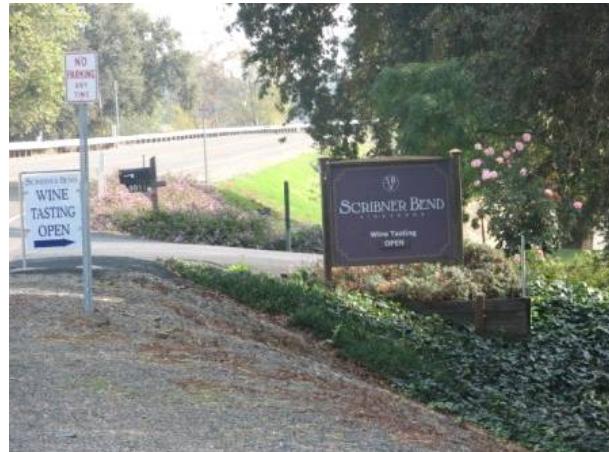
Levee Mile Report Line	201
Start Levee Mile	12.54
End Levee Mile	12.54
Location	Land Side
Category	Earthen Levee
Item	Vegetation
Groundcover has been planted on the levee slope.	johngw_s_20120313_114.jpg

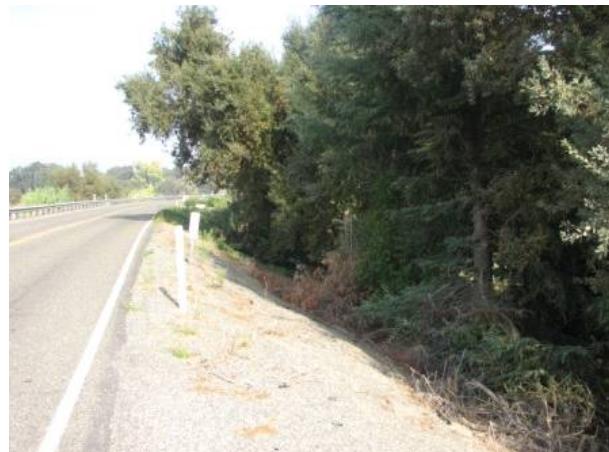
Levee Mile Report Line	203
Start Levee Mile	12.90
End Levee Mile	12.90
Location	Land Side
Category	Earthen Levee
Item	Vegetation
Trees, shrubs, groundcover, and lawn are planted on the levee.	johngw_s_20120313_105.jpg

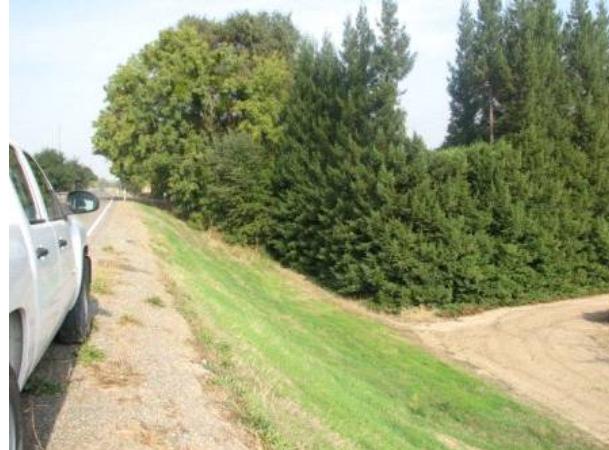
Levee Mile Report Line	204
Start Levee Mile	13.60
End Levee Mile	13.60
Location	Land Side
Category	Earthen Levee
Item	Vegetation
Redwood trees screen a lawn area. The trees are at the toe .	
johngw_s_20120313_103.jpg

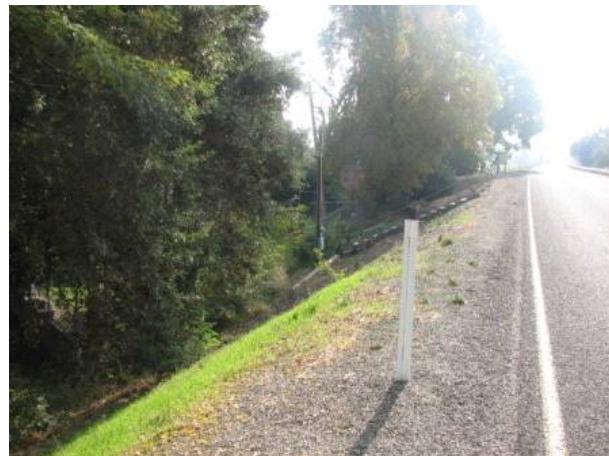
Levee Mile Report Line	204
Start Levee Mile	13.60
End Levee Mile	13.60
Location	Land Side
Category	Earthen Levee
Item	Vegetation
Steps and landscaping on slope in front of the house.	
johngw_s_20120313_104.jpg

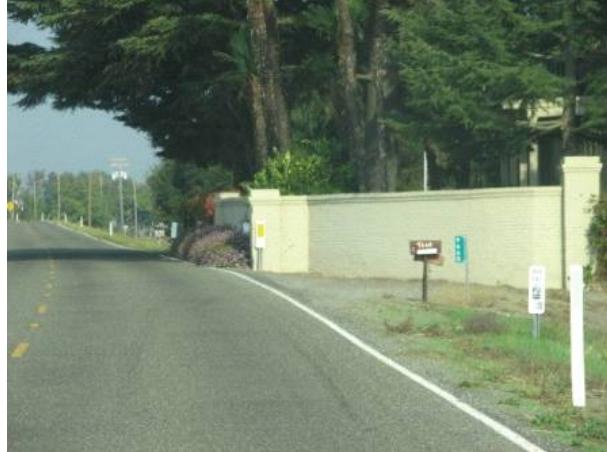
Levee Mile Report Line	206
Start Levee Mile	14.93
End Levee Mile	14.93
Location	Land Side
Category	Earthen Levee
Item	Encroachments
Painted brick wall acts as a sound barrier for the house on the levee.	
<i>johngw_s_20120313_116.jpg</i>

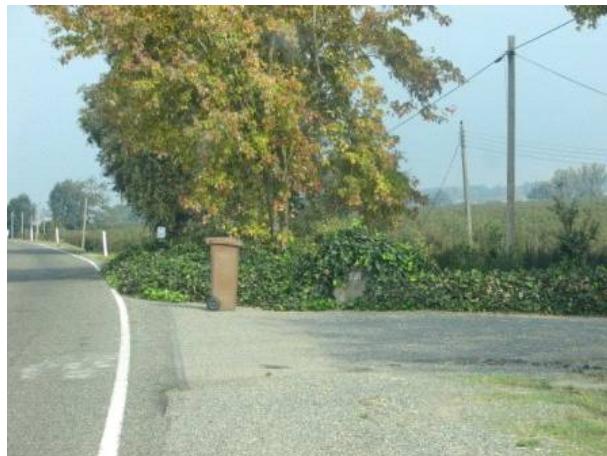
Levee Mile Report Line	207
Start Levee Mile	15.29
End Levee Mile	15.29
Location	Land Side
Category	Earthen Levee
Item	Vegetation
Trees and ivy are planted on the shoulder of the levee.	
<i>johngw_s_20120313_065.jpg</i>

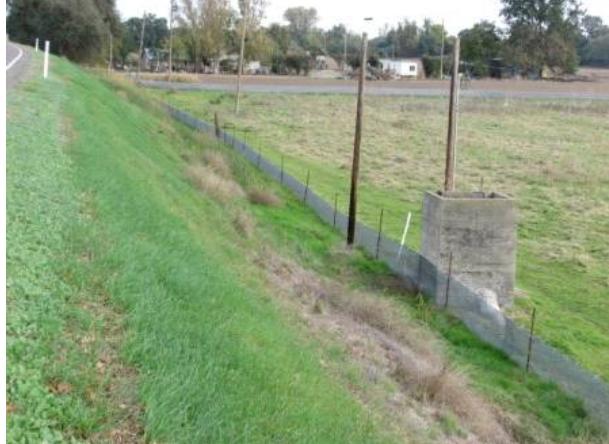
Levee Mile Report Line	210
Start Levee Mile	16.01
End Levee Mile	16.12
Location	Land Side
Category	Earthen Levee
Item	Encroachments

The fence is at toe of the levee.

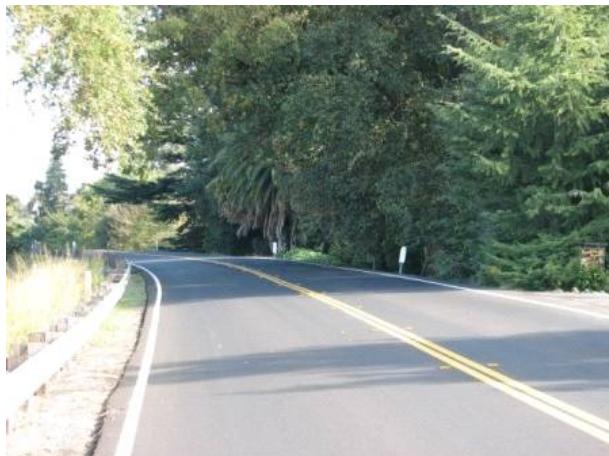
Levee Mile Report Line	211
Start Levee Mile	16.15
End Levee Mile	16.32
Location	Land Side
Category	Earthen Levee
Item	Vegetation

The landscape vegetation is planted on the levee slope and shoulder. Fall 2011

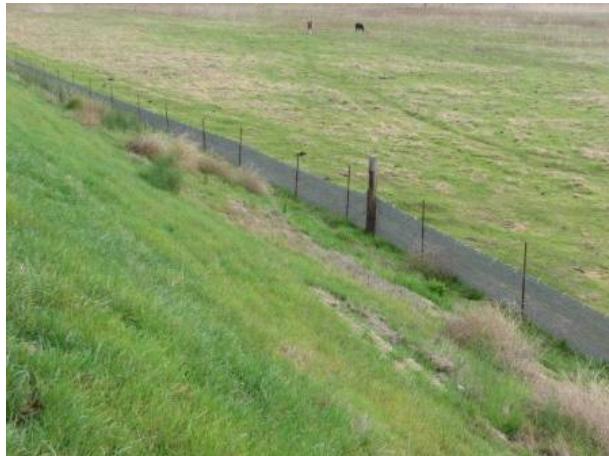
Levee Mile Report Line	213
Start Levee Mile	16.34
End Levee Mile	16.66
Location	Land Side
Category	Earthen Levee
Item	Encroachments

No permit for fence at toe.

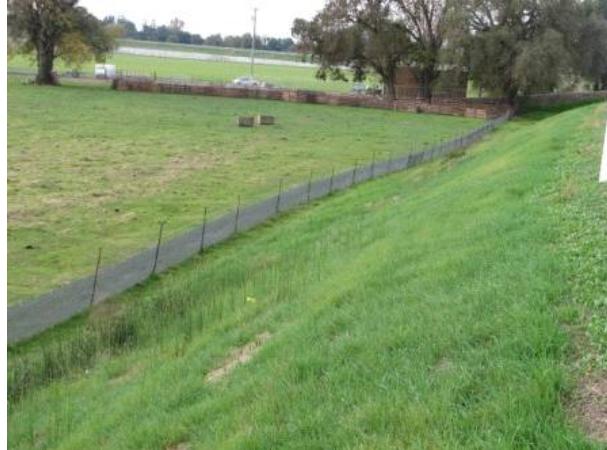
Levee Mile Report Line	213
Start Levee Mile	16.34
End Levee Mile	16.66
Location	Land Side
Category	Earthen Levee
Item	Encroachments
No permit for fence at toe.	
<i>johngw_s_20120313_119.jpg</i>

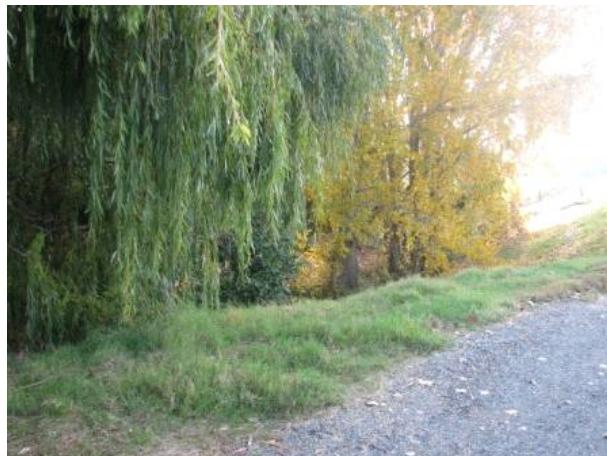
Levee Mile Report Line	216
Start Levee Mile	17.35
End Levee Mile	17.35
Location	Land Side
Category	Earthen Levee
Item	Vegetation
Trees are planted along the toe of the landside slope.	
<i>johngw_s_20120313_099.jpg</i>

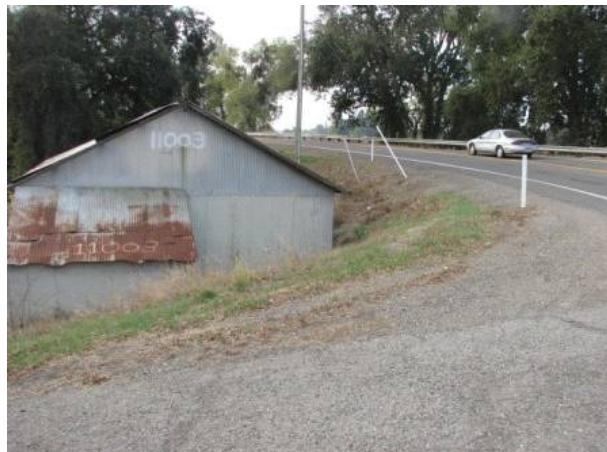
Levee Mile Report Line	219
Start Levee Mile	17.85
End Levee Mile	17.85
Location	Land Side
Category	Earthen Levee
Item	Encroachments
Old pumphouse downstream of Hood building cuts into the toe of the levee. Fall 2011	
johngw_s_20120313_097.jpg

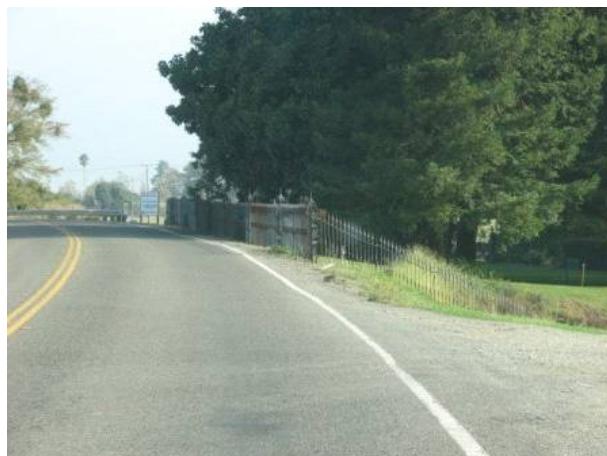
Levee Mile Report Line	220
Start Levee Mile	18.31
End Levee Mile	18.31
Location	Land Side
Category	Earthen Levee
Item	Encroachments
A metal fence is installed along the shoulder of the levee with trees in the yard.	
johngw_s_20120313_055.jpg

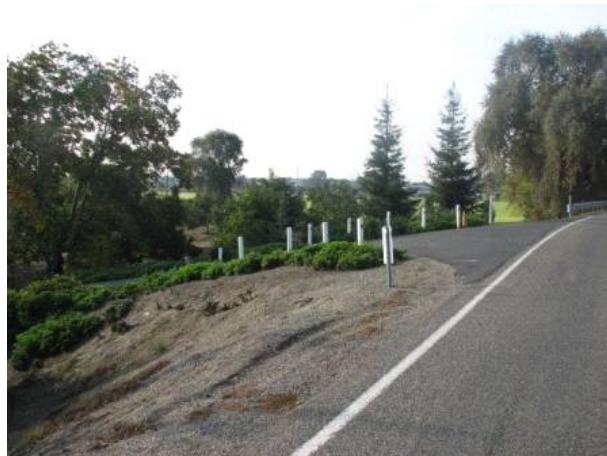
Levee Mile Report Line	221
Start Levee Mile	18.40
End Levee Mile	18.40
Location	Land Side
Category	Earthen Levee
Item	Vegetation
Groundcover and Redwood trees are planted on the slope and along the driveway.	
johngw_s_20120313_096.jpg

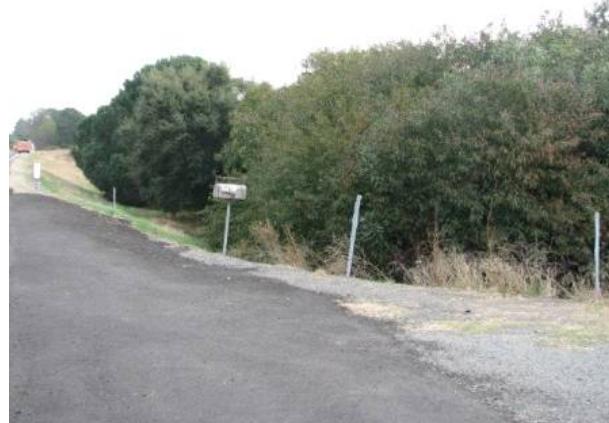
Levee Mile Report Line	227
Start Levee Mile	19.18
End Levee Mile	19.22
Location	Land Side
Category	Earthen Levee
Item	Vegetation
Oleanders line the driveway and are planted on the slope. Tall trees are planted at the toe. Fall 2011	
johngw_s_20120313_094.jpg
